Fabrication and Test of Superconducting Splittable Quadrupole ILC_RTQ_02

C. Hess, V. Kashikhin, M. J. Kim, F. Lewis, D. Orris, M. Tartaglia, T. Wokas

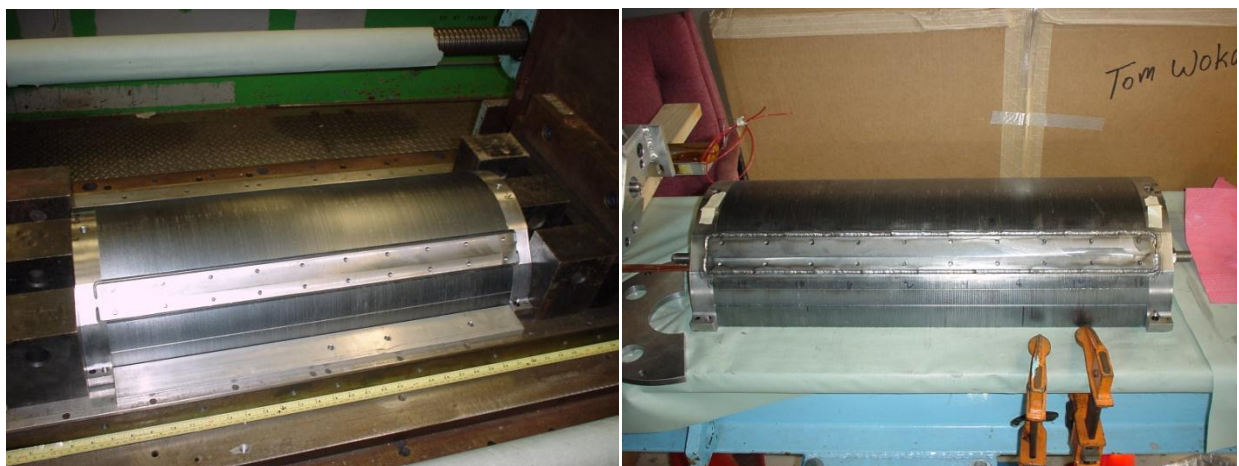
Fig. I-2. Photos of half-yoke laminations in stacking press, before and after welding.

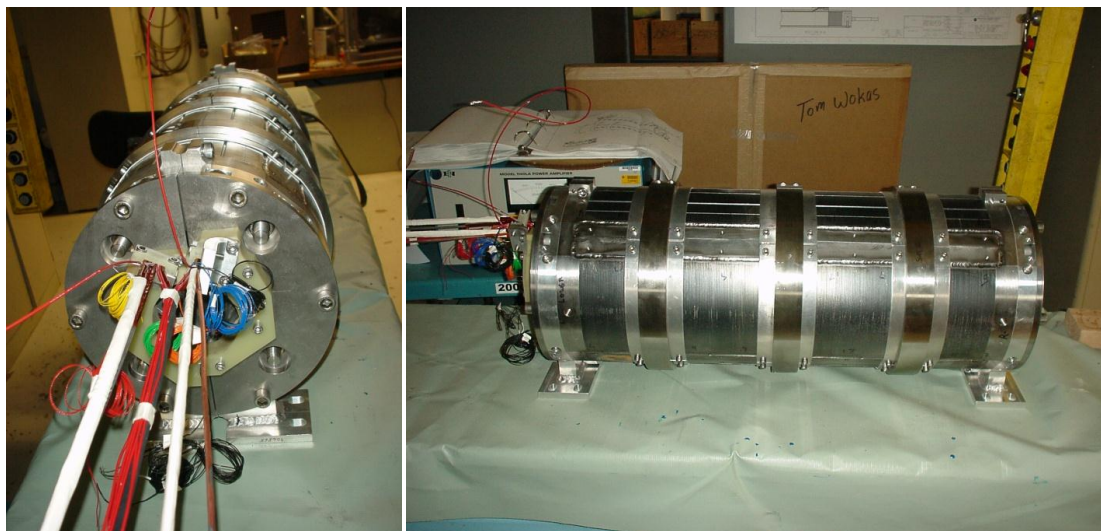
Fig. I-5. Magnet leads (in ILC configuration) and voltage taps, ready for test preparation.

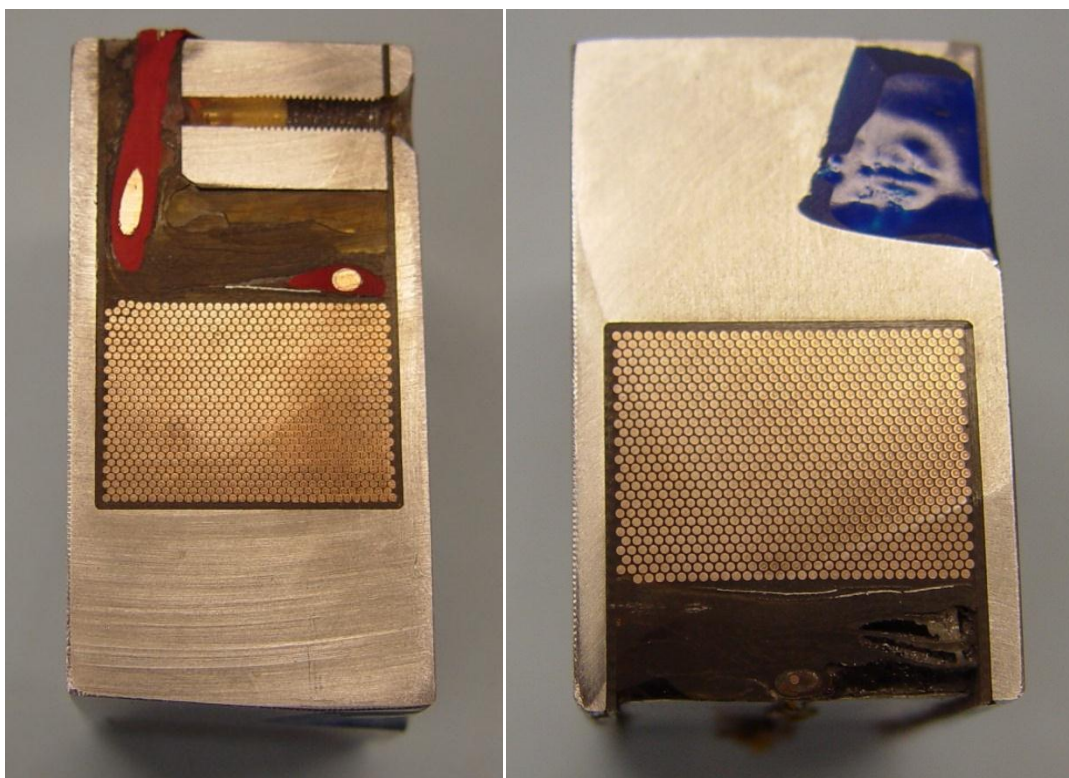
Fig. I-7. Sections of the damaged coil: center of end radius, right end of radius.

- c. The broken coil 3 was later cut into sections to study winding pattern and epoxy impregnation quality. Photos (Fig. I-7 to I-9) of the sections show that the winding is very uniform around the ends (where it is well controlled), and starts out very uniform in the long straight sections but eventually wanders into a less regular arrangement. Some small voids in the epoxy are visible in several of the sections (though not clear in the photos), especially near the corners and outer perimeters of the coil, which may allow motion of individual conductors.

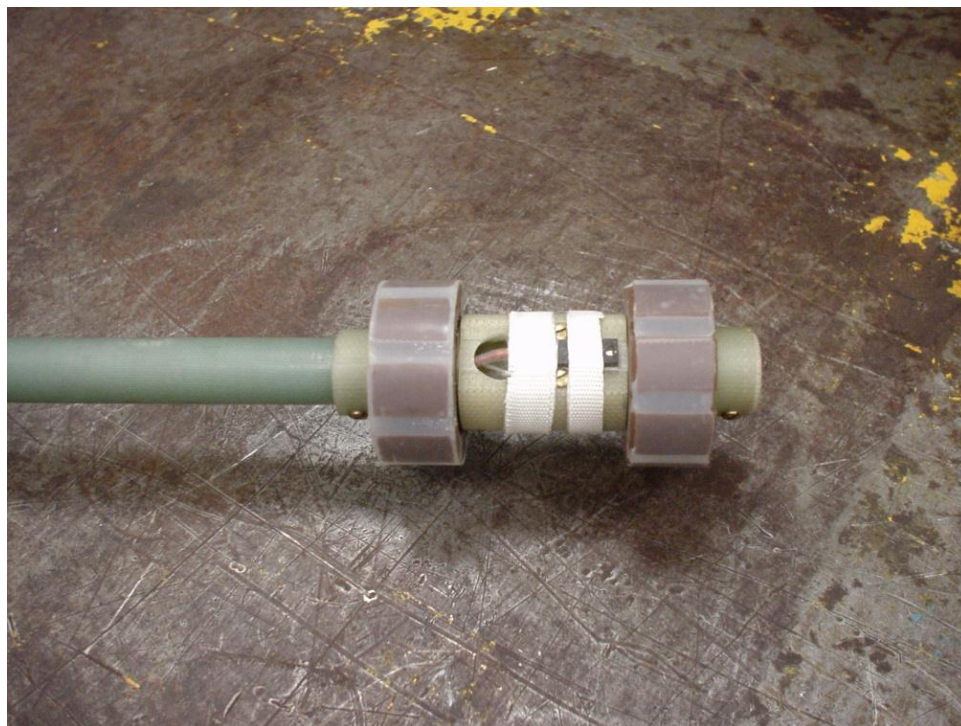
Fig. V-1. Senis 3D Hall probe mounted on a rotating shaft between bearings that center the shaft in the warm bore tube and allow rotation without wobble (at the level of about $15\ \mu\text{m}$).

- a. For the first thermal cycle test program, magnetic measurements were made using a Senis 10 T 3D Hall probe, S/N=5406. (This is a new version of this probe, with a 2 m long cable, calibrated with 0.1% linearity to 2 T). The Hall probe mount, shown in Fig. V-1 is the same one used for HINS CH solenoid magnetic axis studies (TD-10-007), but with new close-fit bearings to center the shaft and probe without gaps in the warm bore tube; the probe active element was approximately 8.0 mm radially out from the axis of rotation, with an error of about 0.1 mm (although not necessarily centered on the quadrupole axis). Probe angular orientation and axial positions were measured with precision encoders (.0025 degrees, .01 mm). The probe was mounted so that the B_y readout corresponds to the radial field component (about the axis of rotation), B_x corresponds to the tangential field component, and B_z corresponds to the axial field component. The Hall probe voltages (V_x , V_y , V_z) and temperature (V_t) were digitized 10 times at each {Z, angle, Current} setting, using a Keithley 2700 multiplexing DMM. Following the test, the B_x and B_y Hall elements were calibrated against an NMR reference in the MTF calibration magnet, up to about 2 T. It was found that both elements agreed within .05% of the NMR field strength.
